Test Report No. XMNMLC1800489803 Date: 13 Jun 2018 Page 1 of 3

FOSHAN IFORLONG PLASTIC MATERIAL MANUFACTURE CO.,LTD

The following sample(s) was/were submitted and identified on behalf of the clients as: Iforlong PVC Flooring

Specification: 2.0mm*2.0m*20m

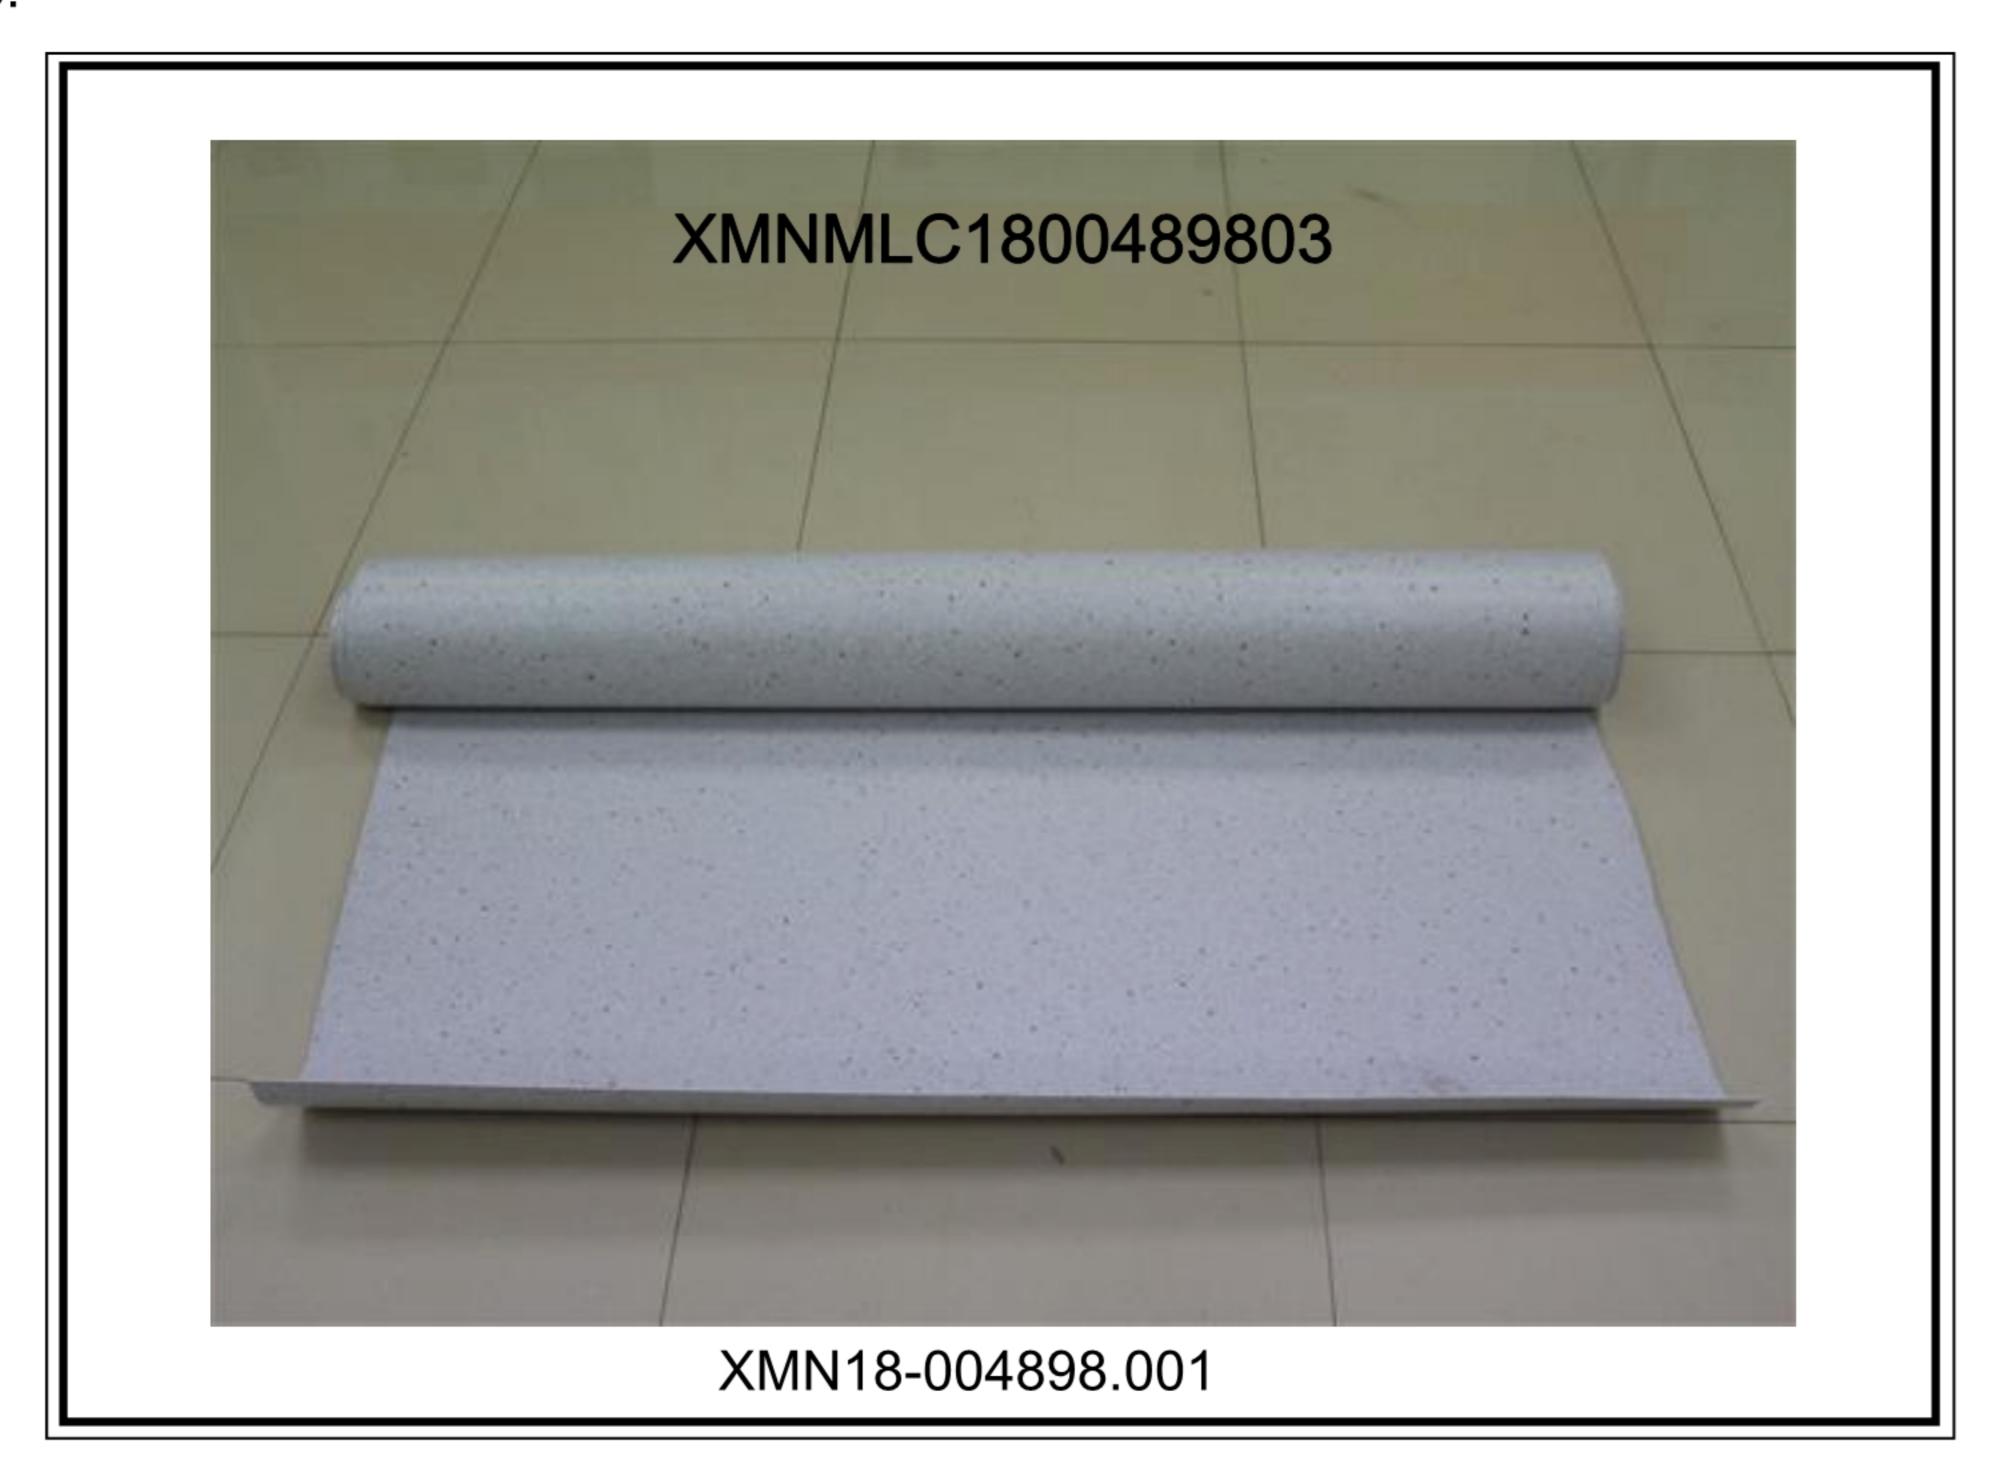
Sample photo:

XMN18-004898.001 Multicolor(brown, gray, lt-gray) surfaced white plastic SN1
