TEST REPORT

No. : XMIN180100046CCM

Sample Name : IFORLONG PVC FLOORING

Slip resistance (oil-wet ramp test)

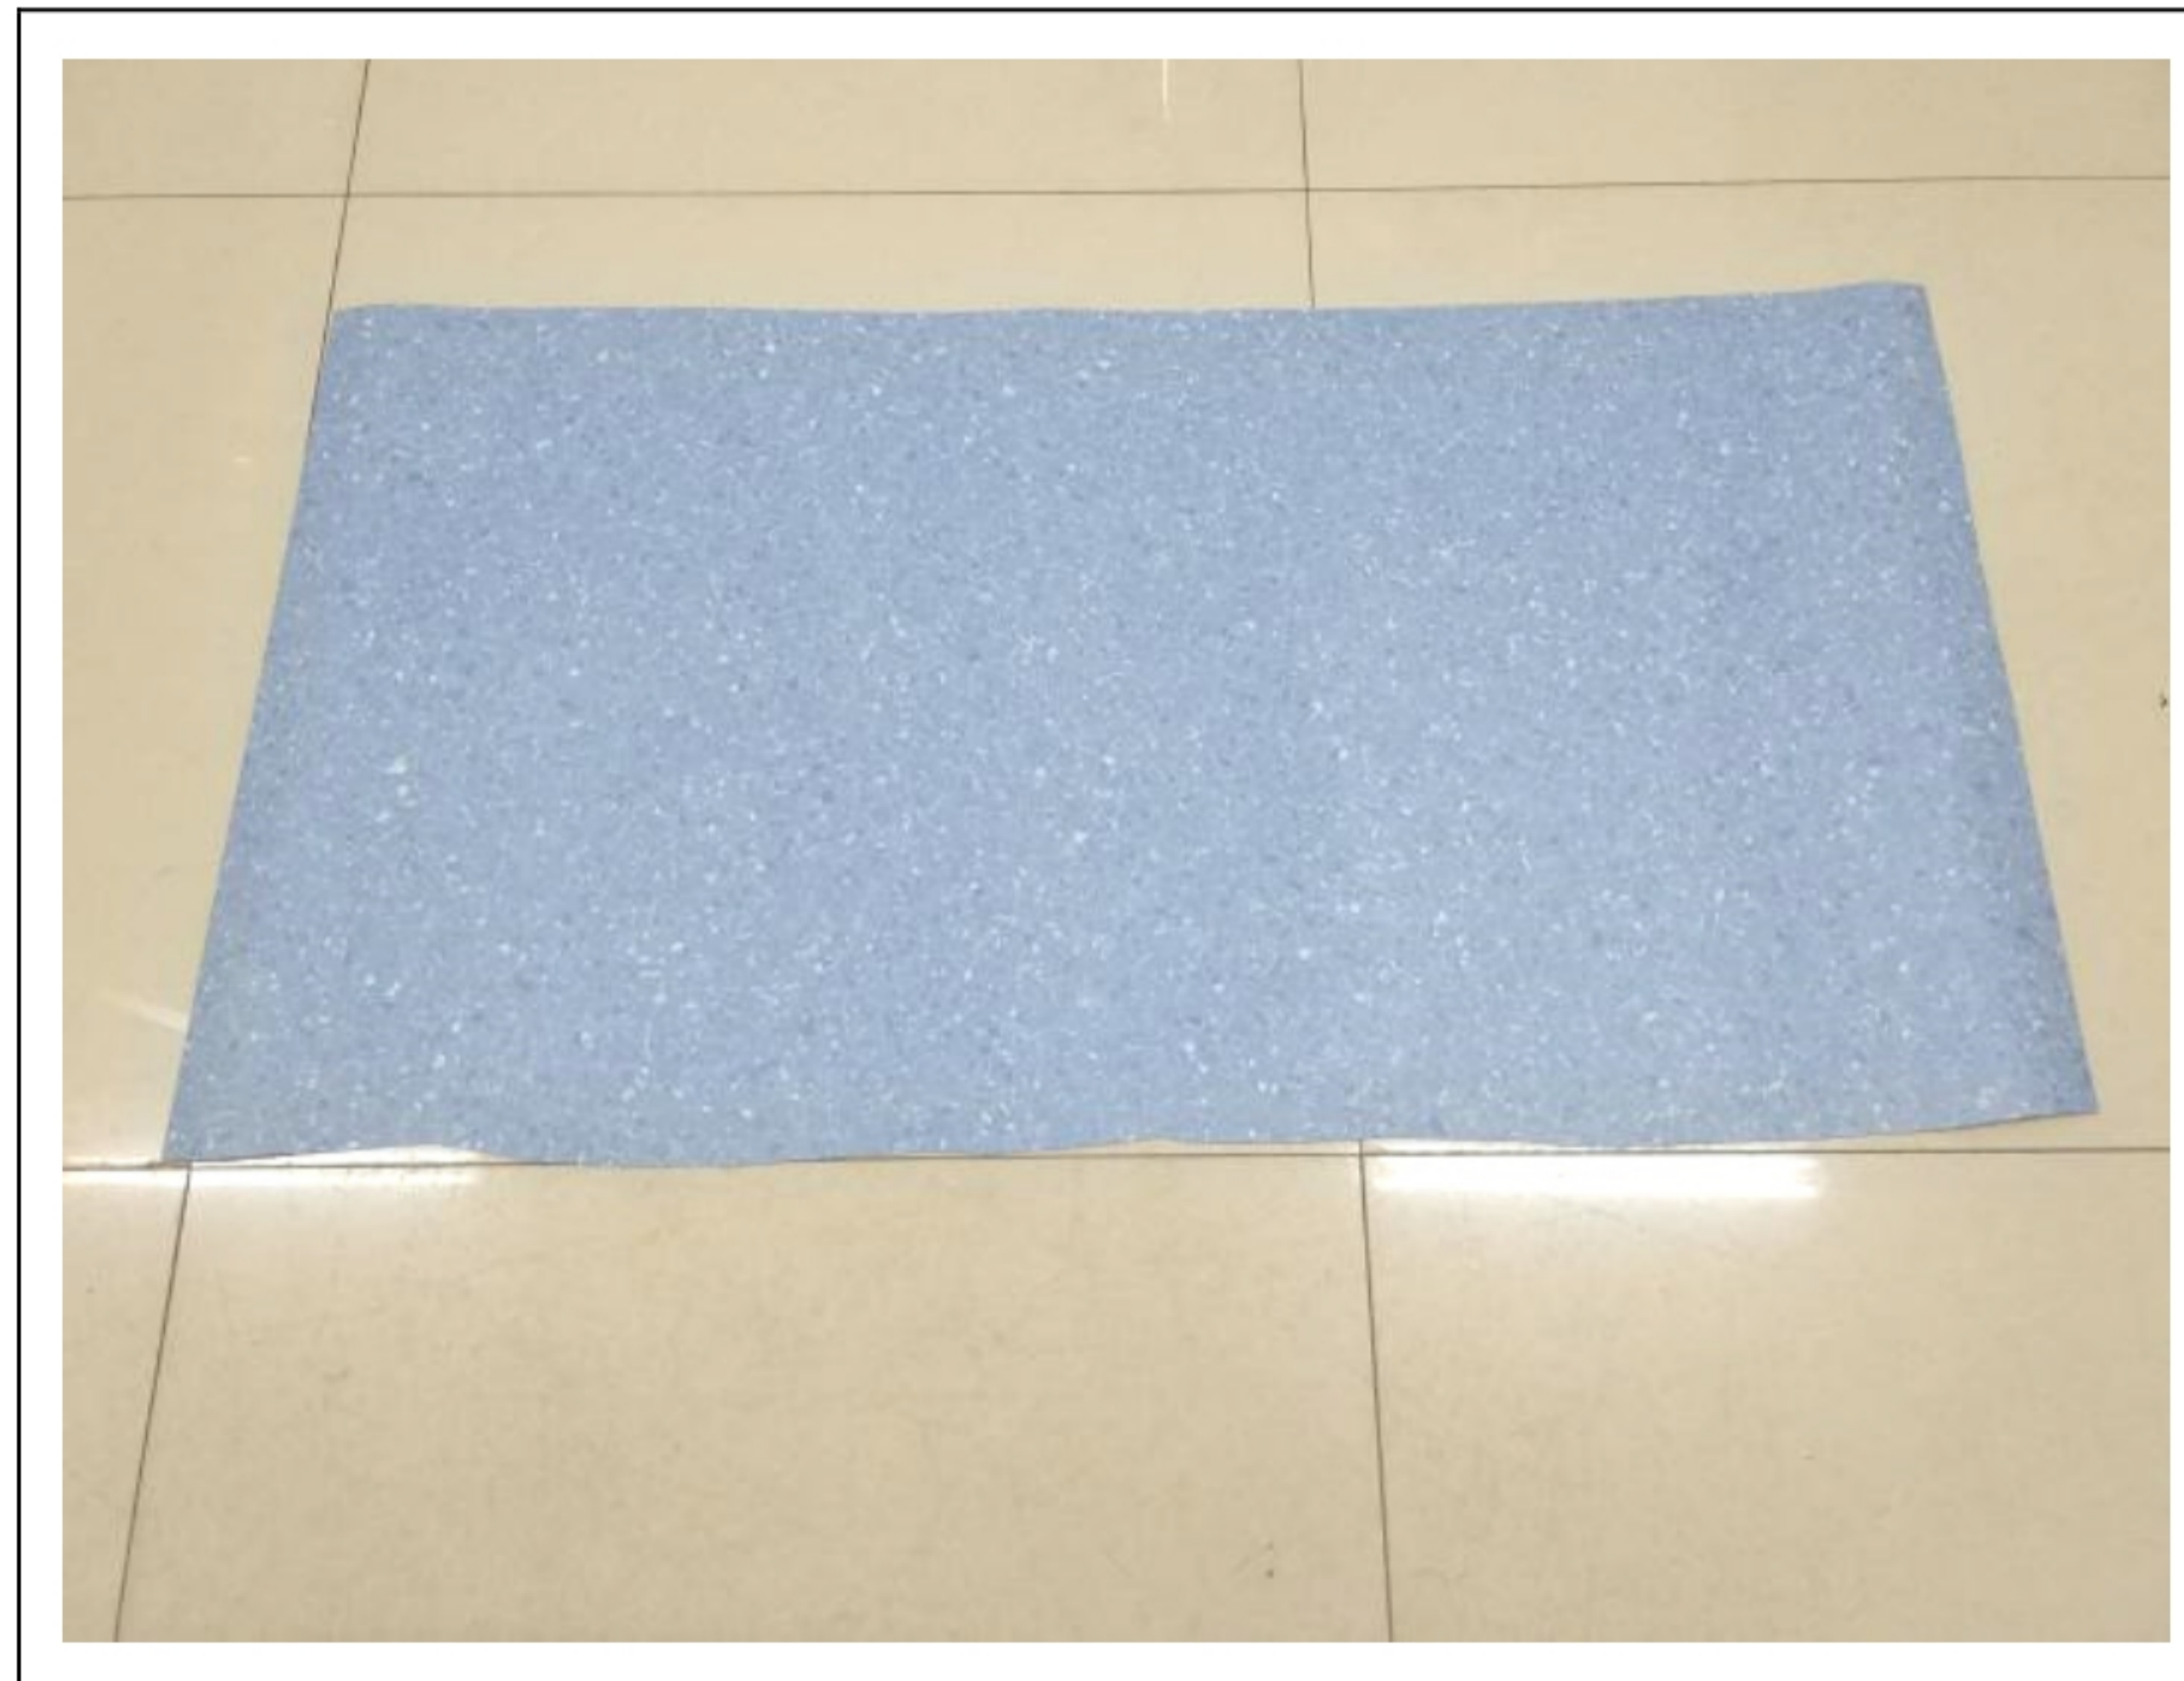
Specimen photograph:

PVC flooring, 1000mm×500mm, see the photo

Test item(s)	Test result(s)	Classification
Slip resistance (oil-wet ramp test)	Critical angle of inclination: 9.0°	R9
